Hardware data sheet section III addendum

ET1810 / ET1811 / ET1812 and ET1815 / ET1816

EtherCAT[®] Slave Controller IP Core for Altera[®] and AMD[®] FPGAs

Version 3.2
Date: 2024-03-13

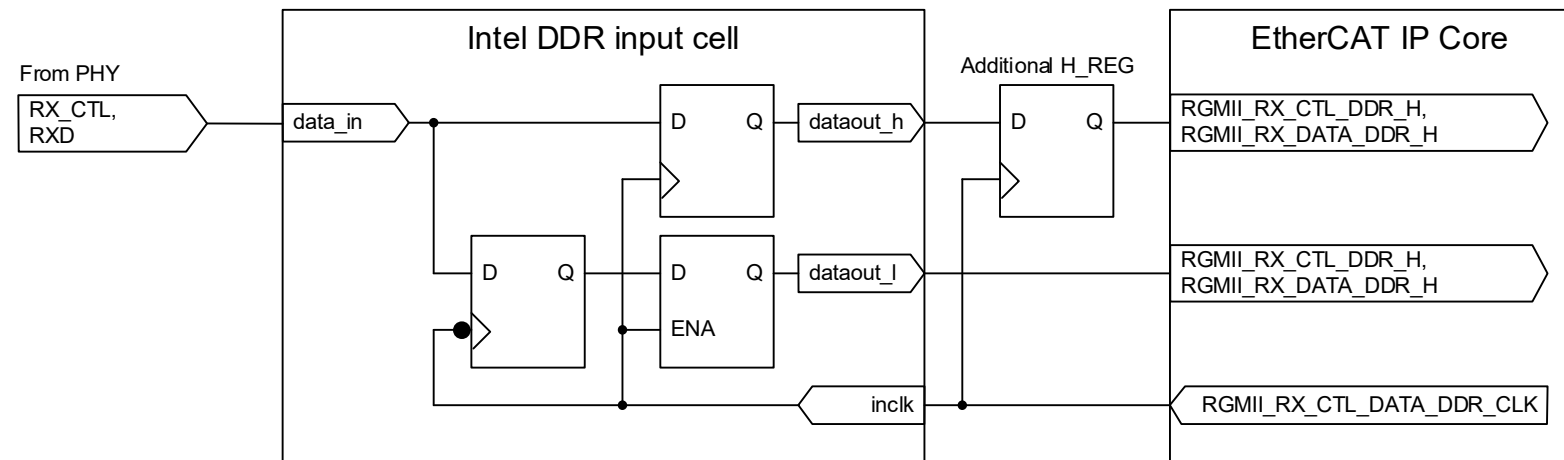
Figure 1: Additional H_REG for RGMII inputs using Altera DDR input cells

2.4.2.1 EtherCAT IP Core before V3.0.10 Patch 3: DE2-115 NIOS RGMII example design is missing a register for DDR input signals

The DE2-115 NIOS RGMII example design uses an Altera DDR input cell which uses a reversed DDR_L/DDR_H ordering. Due to a certain behaviour of the PHYs on this boards, this will not cause problems, but using the example design for other PHYs can result in receive errors.

An additional register has to be added to the DDR_H path for each RX_CTL/RX_DATA[3:0] signal, according to the following schematic:

Example code for the additional H_REG for one port (duplicate and update port numbers for additional ports):
